Northeast view from first floor corridor to the Lobby, during renovation of White House

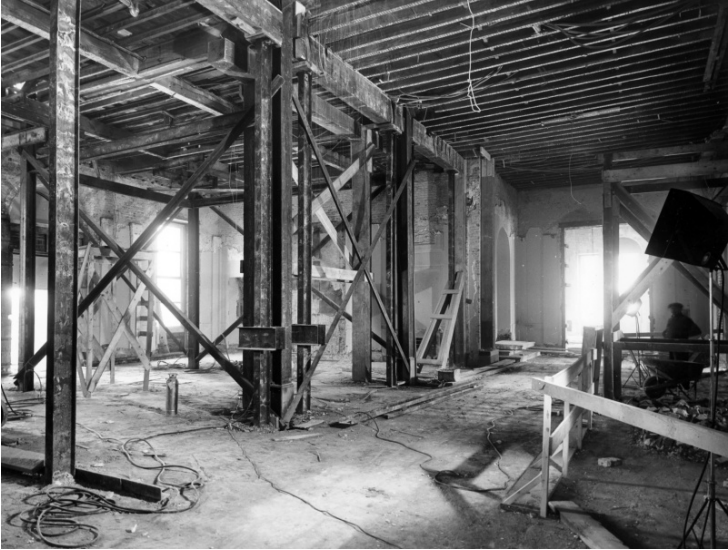
Northeast view from first floor corridor to the lobby, during the White House renovation. The four temporary steel shoring columns installed on concrete foundations 30 feet below grade go through the Lobby to the third Floor level.
