West view of entire length of the lower corridor during renovation of White House

March 13, 1950

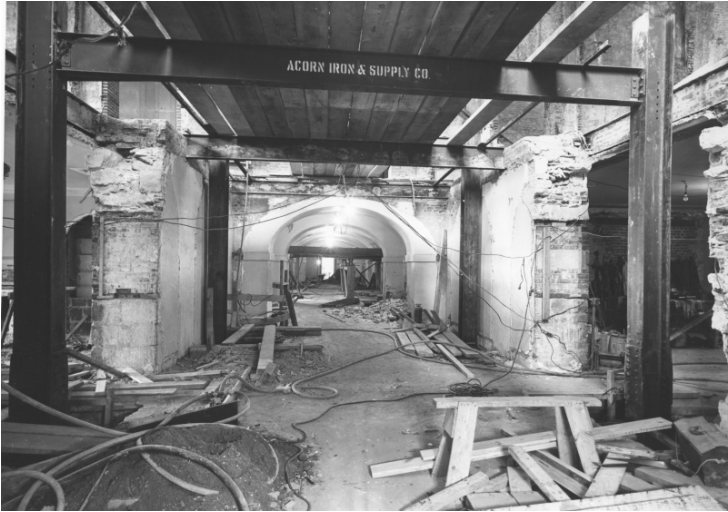
West view of entire length of the lower corridor during the renovation of the White House. The shoring columns in the foreground to the first floor are permanent, while the columns beyond are temporary. The extension of these columns to the third floor will be temporary to support the roof during construction.
