# Northwest view on second floor above the East Room during White House renovation

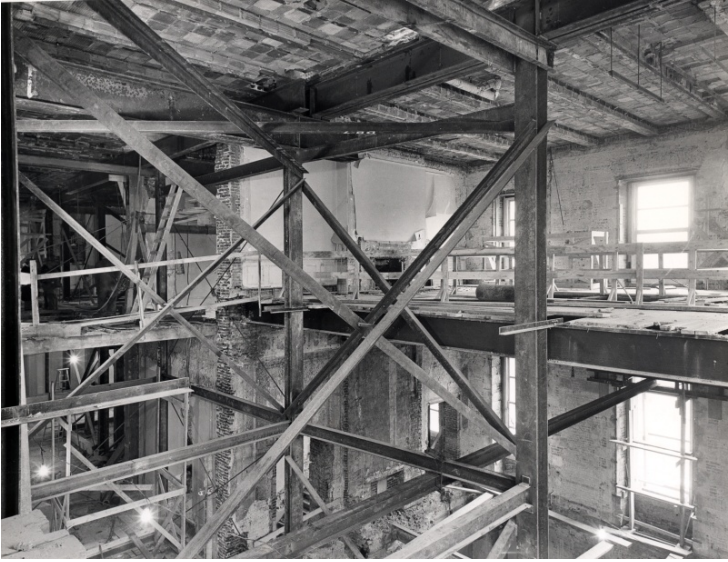
Northwest view on second floor above the East Room, showing temporary steel columns for supporting the roof and third floor during the renovation work. The long steel beam below, running north and south above the central windows, was installed to support the walls and to prevent bulging during the work.
