# View of North Hall of 3rd Floor Corridor during renovation of the White House

## Description

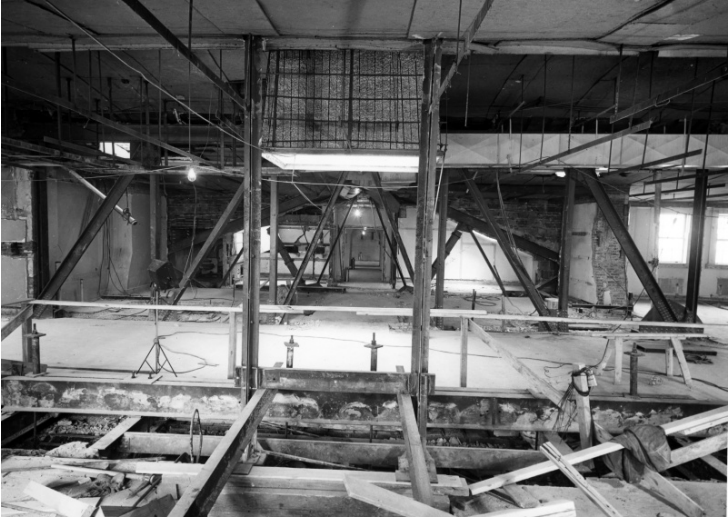
View of North Hall of 3rd Floor Corridor from the steps of the Sun Parlor on the south, taken during the renovation of the White House. From the temporary steel beams in the foreground, across the steel beams of the 3rd Floor, tie-rods were installed to hold up the 2nd Floor below.
