# Northeast view from the concrete beam during renovation of the White House

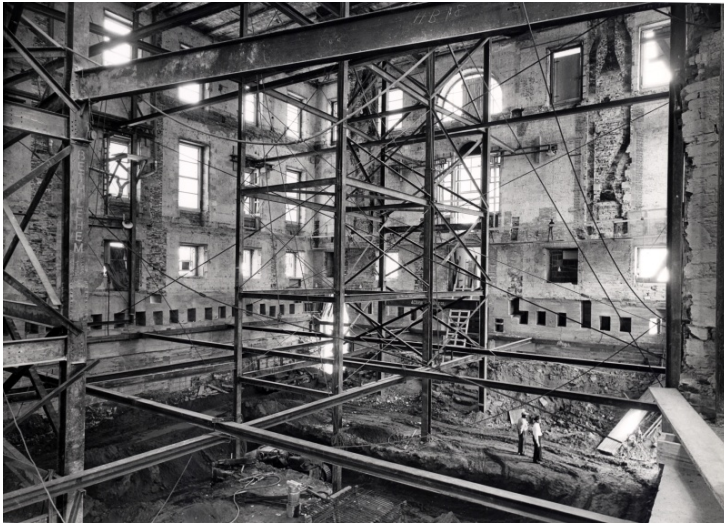
Northeast view from the concrete beam at the south central part of the White House showing the permanent and temporary supporting columns. The temporary horizontal beams, running from the north to the south wall, were installed to prevent walls from bulging during excavation below the basement level.
