View of installation of concrete sewer during renovation of the White House

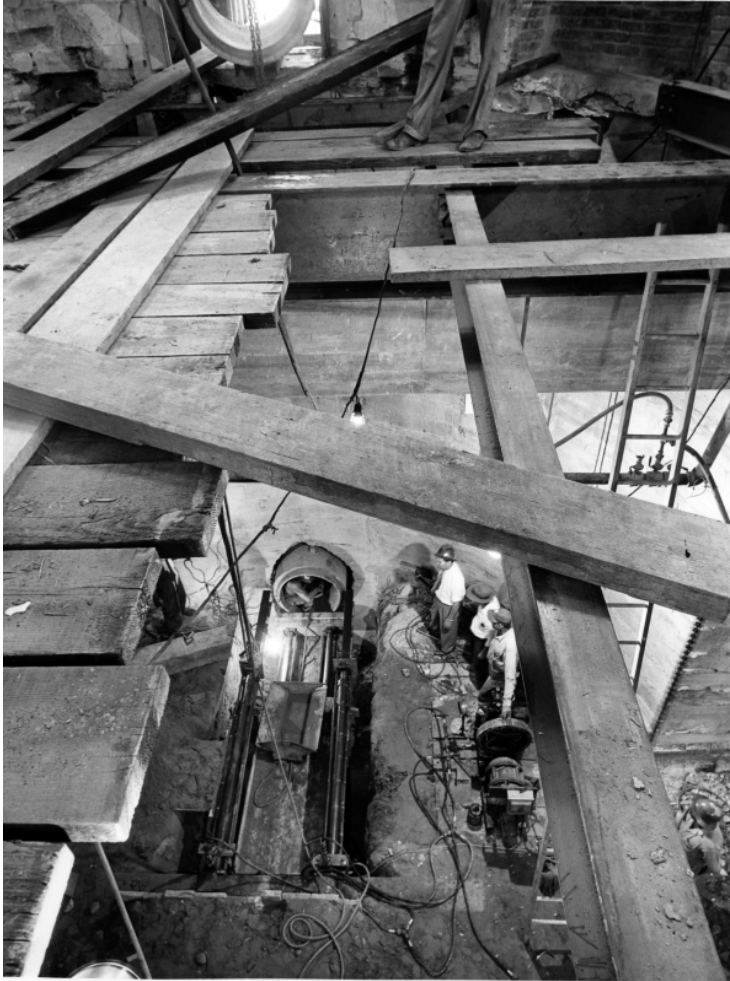
View of installation of concrete sewer at the base of the underpinning wall at the center of south wall of the White House. A workman, excavating within the 36" sewer, fills the cart which is pulled out and emptied. The hydraulic jacks force the sewer sections into excavation area.
