View at the northwest corner of White House during renovation

July 26, 1950

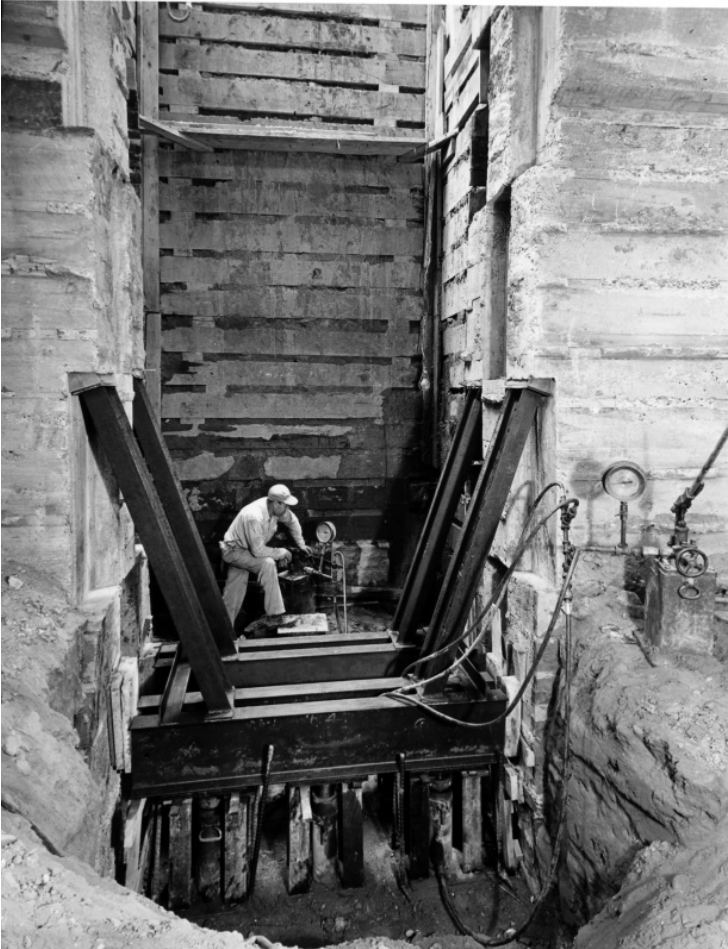
View at the northwest corner, outside and below the north window of Room G-17, during the renovation of the White House. The installation is to test the strength of the foundation. The horizontal iron beams are supported by six vertical columns, below which is a two foot concrete foundation. Iron struts were erected to the wall at each side. A shift downward of 1/16" to 1/4" was recorded when four hydraulic jacks, each with a pressure of 50 tons, were applied to test the foundation.
