View along north wall looking east during White House renovation

July 14, 1950

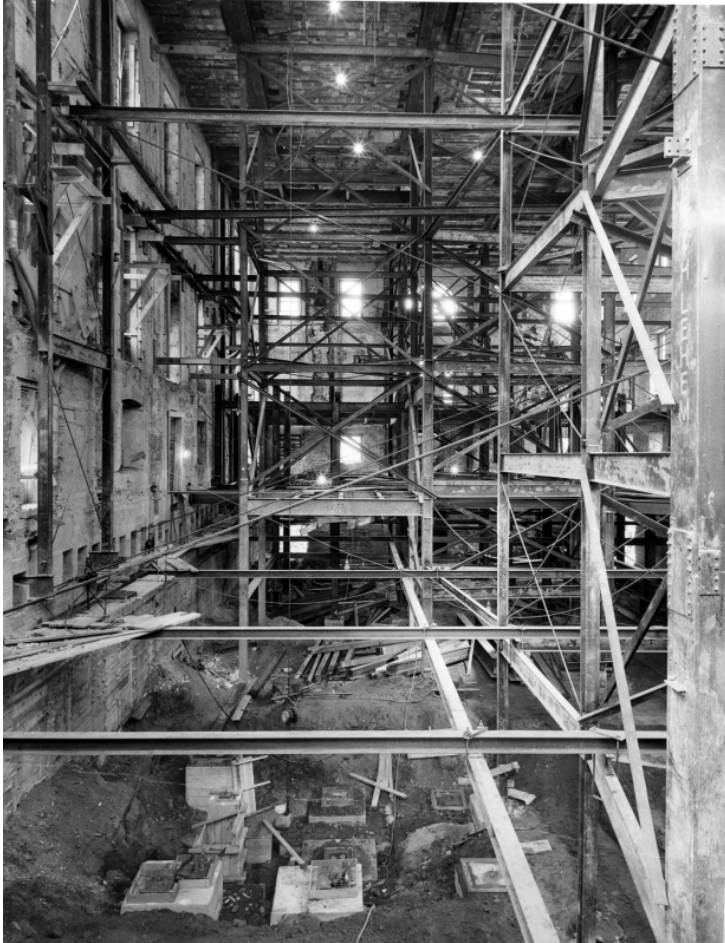
View along north wall looking east from the window of G-17 during the renovation of the White House. The concrete footings are for permanent steel columns to be erected on the line of the west wall of the lobby and east wall of Family Dining Room.
