Manchu Iron Works - Anshan, Manchuria

Manchu Iron Works in Anshan, Manchuria. View of tapping side of Number 8 blast furnace. Of the nine furnaces at Anshan, Number 8, which had been undergoing repair just before the end of the war, is in best condition for resuming operation at an early date.

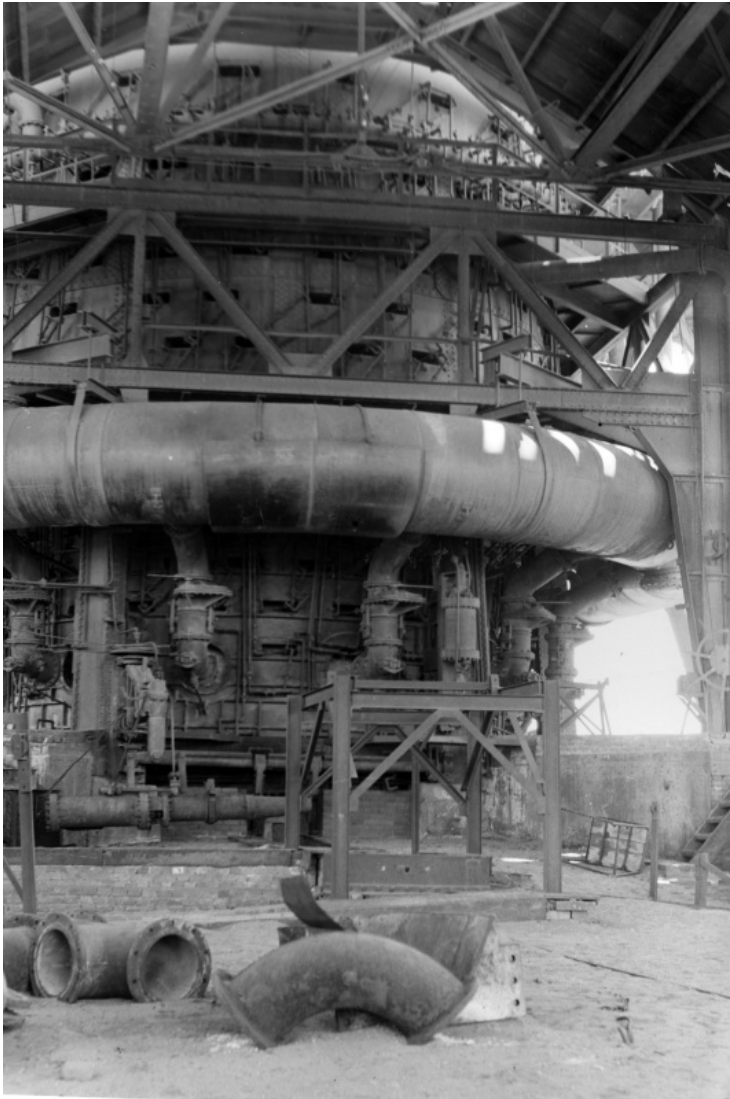
However, before it can be blown in, adequate blowing facilities must be installed and numerous parts must be "cannibalized" from some of the other eight furnaces in order to restore Number 8 to an operable condition. Photograph taken during the U.S. Reparations Mission. Edwin Pauley was the U.S. Ambassador on the Allied Reparations Committee from 1945-47 (the committee that assessed the reparations the Axis powers could afford to pay the victors).
