# Unidentified Men Inspect a Spillway in Lind, Washington

## Description

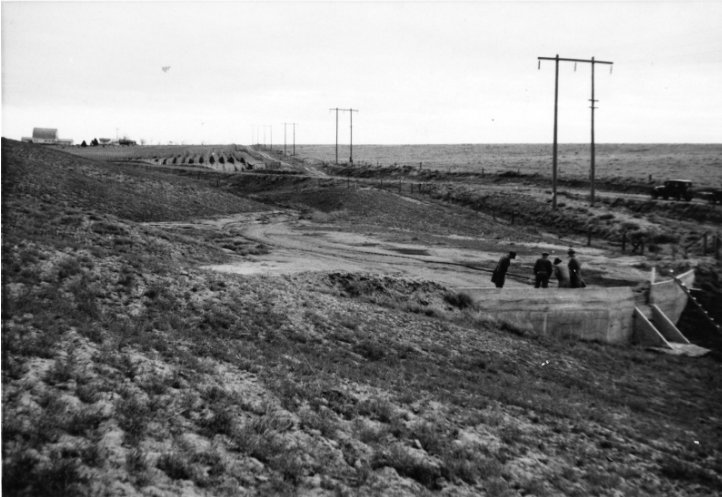
Unidentified men inspect a spillway in Lind, Washington. On the back of the photo, Lyle Watts writes, "Lind, Wash. Rain of .13 inch on Jan 15, 1931 deposited 12 000 cu. ft. soil above dam filling dam to crest of spillway. Drainage area 871 acres. Soil was frozen at time of run-off. Maximum flow was 79 cu. ft. per sec."
